Corrosion resistant ALD coatings

**EE412 Final
Presentation**

**Joey Doll
Alex Haemmerli
Mentor: J Provine**

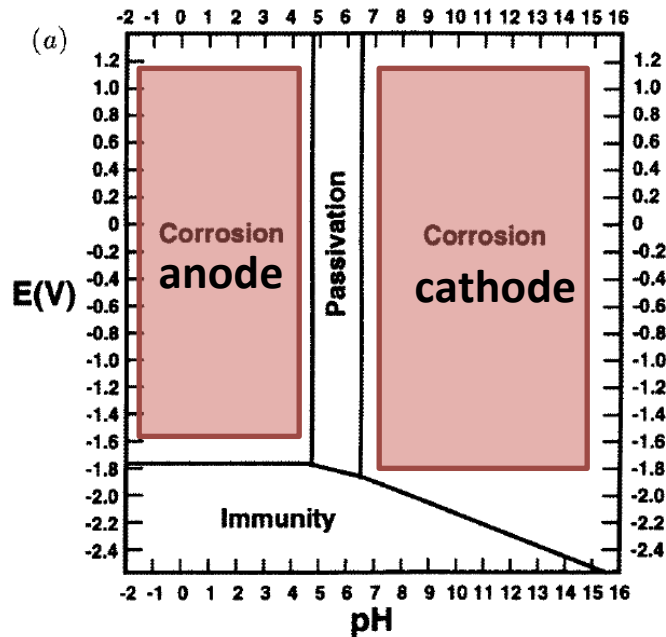
Pourbaix diagram for Al

Al cathode reaction:

(Al corrodes at the anode or cathode)

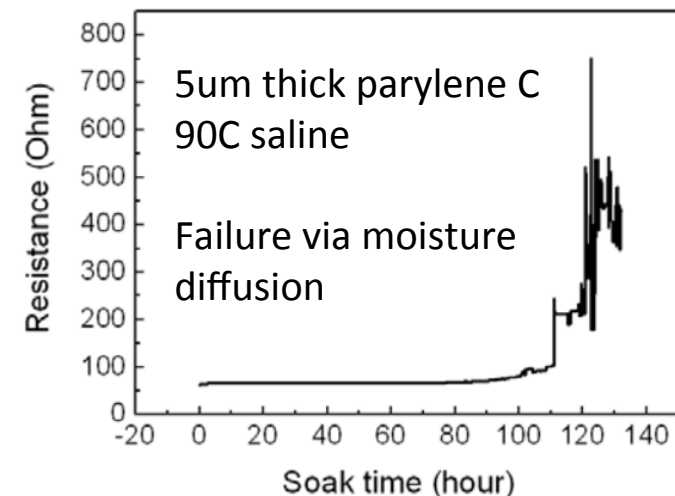
- LPCVD dielectrics
- PECVD dielectrics
- LPCVD polymers (parylene)
- Considerations
 - Deposition temperature
 - Conformality/thickness/mechanics
 - Electrical properties (breakdown, leakage)
 - Moisture permeability

From "Corrosion behavior of parylene-metal-parylene thin films in saline", W. Li et al, ECS Transactions (2008)

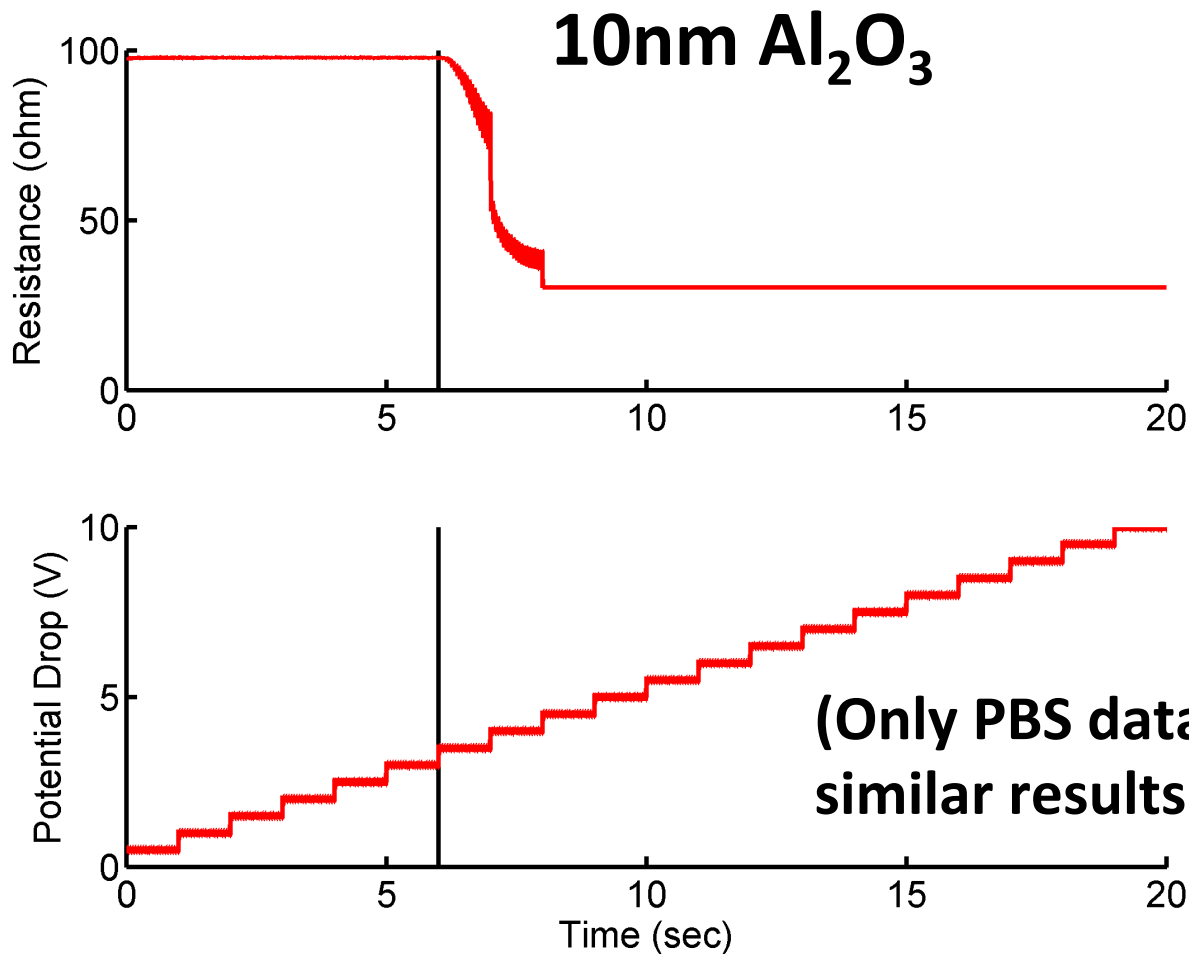
Ramped Breakdown Test

- 1) The resistor shorts out when corroded (due to the 3-wire setup)
- 2) The capacitor is more sensitive to defects due to its higher impedance

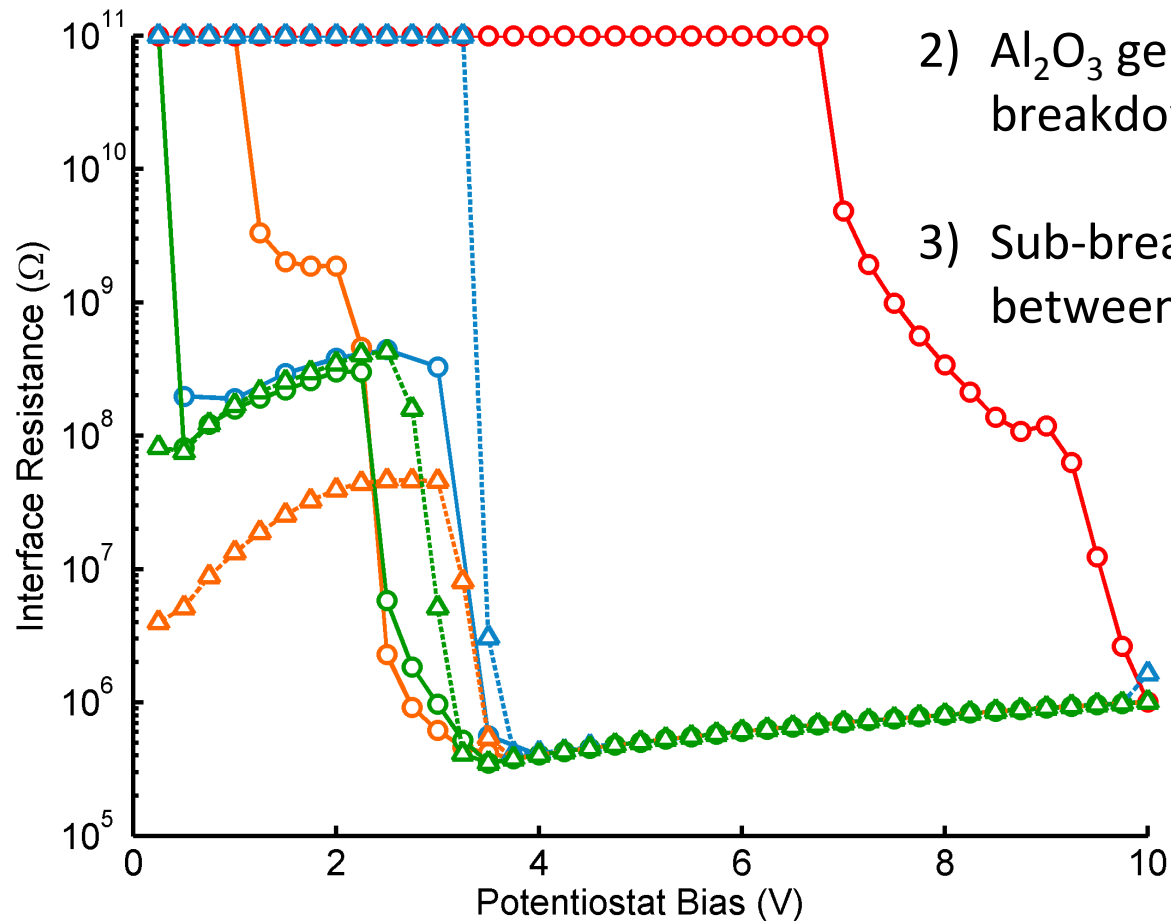
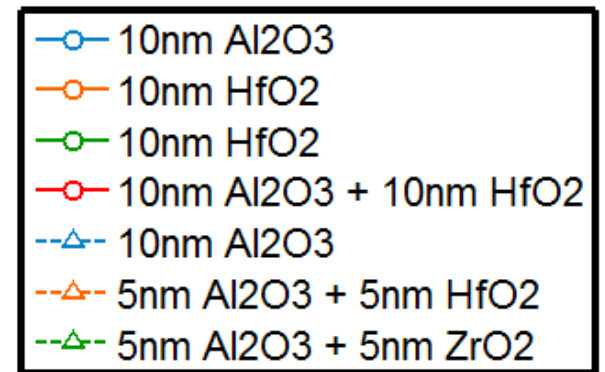
Breakdown comparison

1) All films broke down @ 0.25-0.35 V/nm
(vs. 0.8-1.5 V/nm in EE412 Fall 2010)

2) Al_2O_3 generally provided a sharper
breakdown point (i.e. fewer defects)

3) Sub-breakdown behavior varied
between identically prepared samples

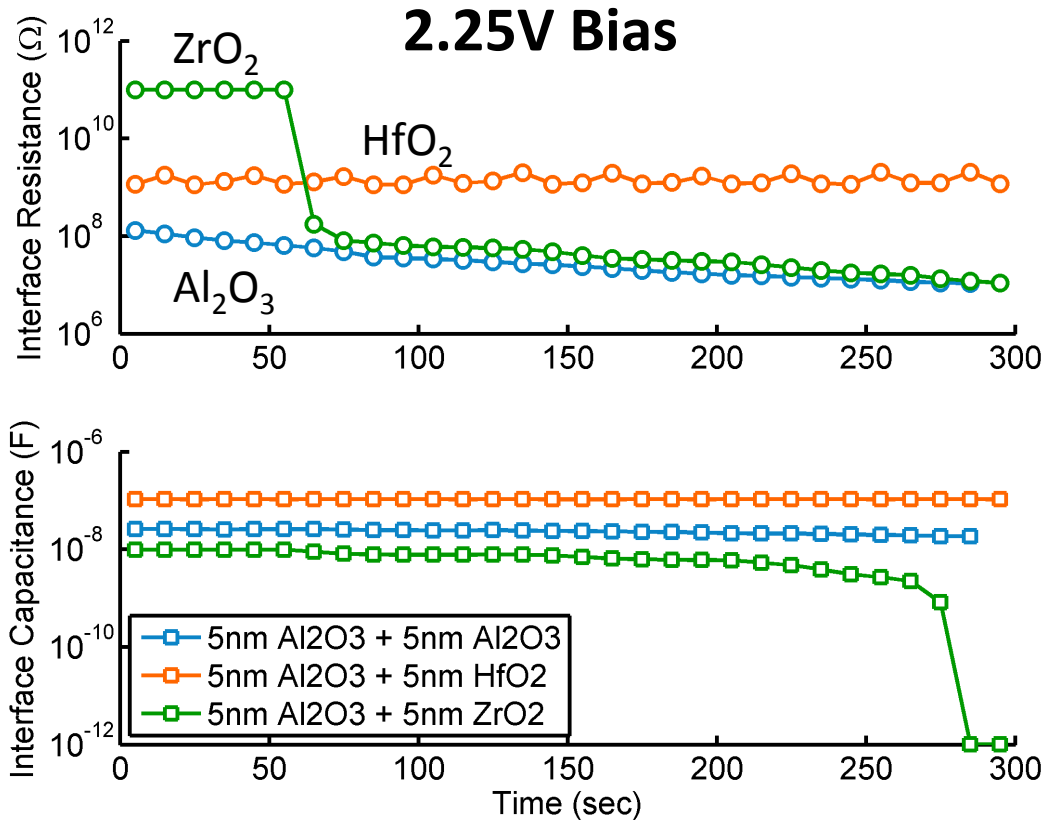
Time comparison

- 1) HfO_2 may provide better long term stability than Al_2O_3 or ZrO_2 (but need more data)
- 2) 10nm Al_2O_3 stable @ 1V for 15 hours (not shown)
- 3) Coatings are generally stable for minutes to hours at <50% breakdown voltage
