Characterization of Fiji ALD Film Quality and Conformality in High Aspect Ratio/Deep Etched Structures

Introduction

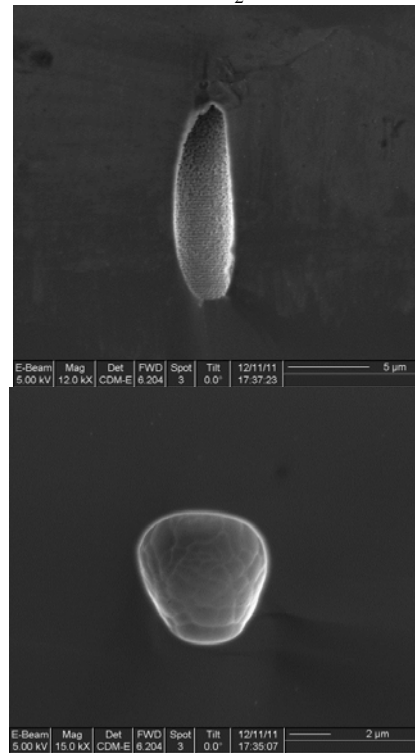
Without SiO_2 sidewall

Both sidewalls and undercuts showed no sign of XeF_2 attack

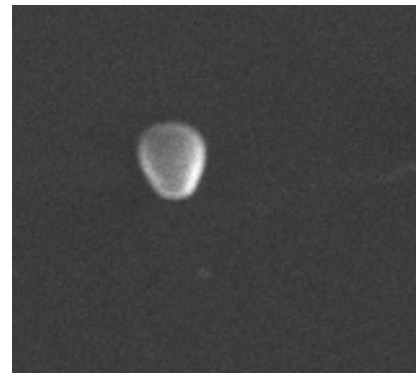
Without SiO₂ sidewall

Without SiO₂ on the sidewall, Al₂O₃ film protected sidewall fairly from XeF₂ attacks but there could be some pinholes since Undercut structure remained same and protected by Al₂O₃ film.

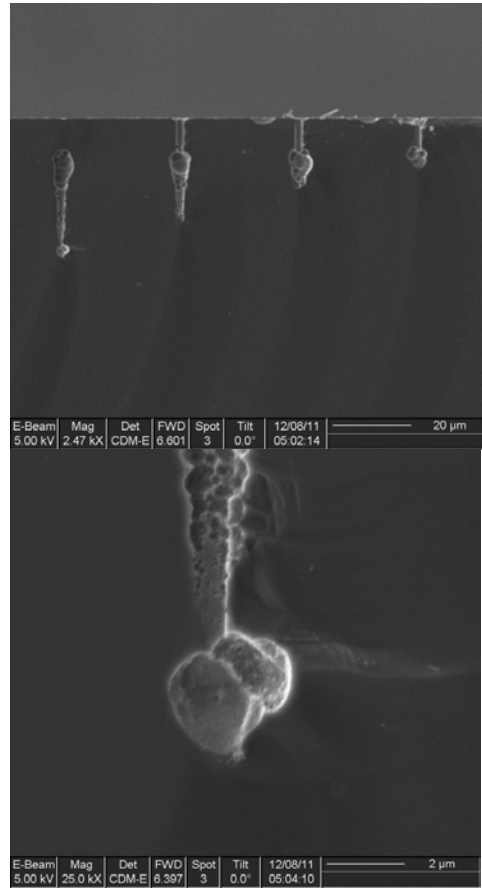
Without SiO₂ sidewall

Without SiO₂ on the sidewall, XeF₂ attacks sidewall heavily. Sidewall was deformed by the attack. Undercut structure was attacked by XeF₂ and deformed severely.
